# Manhole Inspection Summary

Manhole # S21GG\_034MH

Insp Date: **6/19/07 10:00 AM**

**Location** Address: **1713 BAKER-PRESSTMAN**

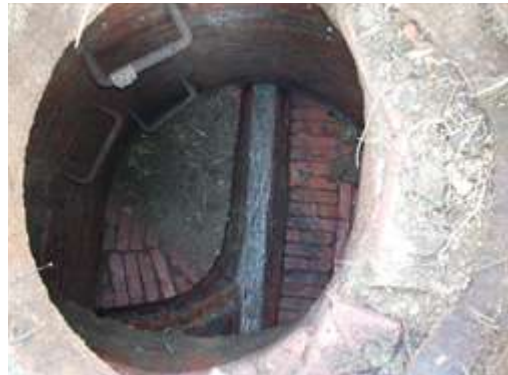
Top View

DEBRIS ON BENCH

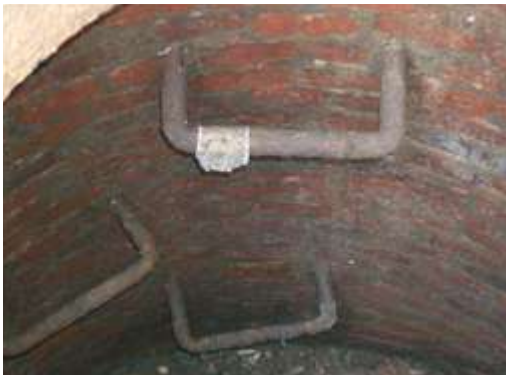
Defect 3

Count: **3** Missing: **0** ☒ **Corroded**

CORRODED STEPS

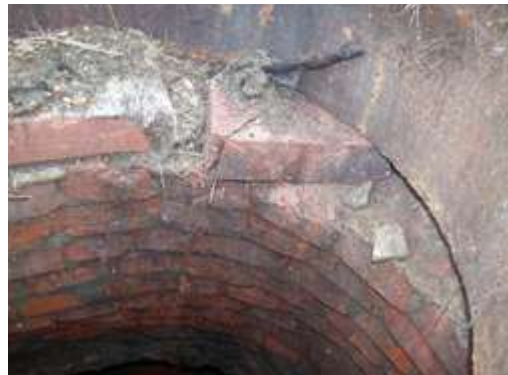
Defect 2

Condition: ☐ Sound ☐ Cracked ☐ Root Intrusion ☒ **Loose Brick** ☐ Deteriorated

LOOSE CHIMNEY BRICKS

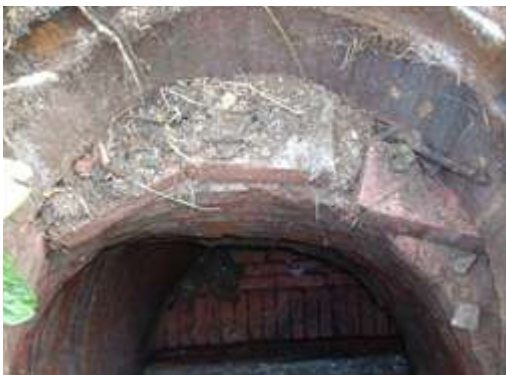
Defect 1

Offset: **4** (in.)

FRAME OFFSET

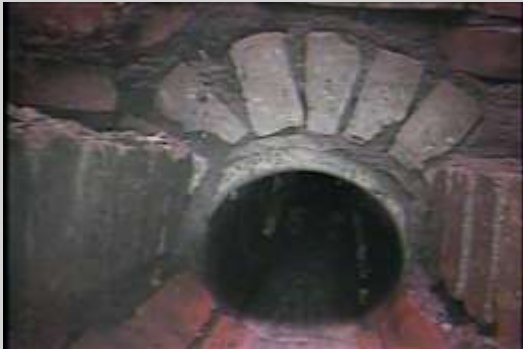
12 O'Clock Outflow

8 in. Circular Gravity Sewer  
Pipe Out @ 12 O'Clock

Pipe Height: **8.4** (in.) Rod and Bar (Angled)  
Pipe Material: **Clay** ☐ Pipe Lined  
Invert Depth: **7.86** (ft.) Flow Characteristics: **Slow**  
Deposits: ☒ None ☐ Mud ☐ Sludge ☐ Debris ☐ Grease  
Silt Depth: (in.) Deposits Extent:  
Infiltration: **None** Pipe Seal Cond: **Sound**

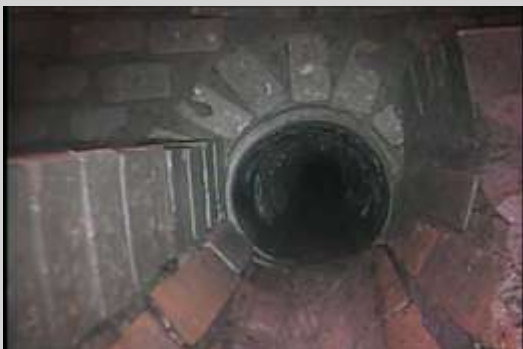
6 O'Clock Inflow

8 in. Circular Gravity Sewer  
Pipe In @ 6 O'Clock

Pipe Height: **8.4** (in.) Rod and Bar (Angled)  
Pipe Material: **Clay** ☐ Pipe Lined  
Invert Depth: **7.69** (ft.) Flow Characteristics: **Slow**  
Deposits: ☒ None ☐ Mud ☐ Sludge ☐ Debris ☐ Grease  
Silt Depth: (in.) Deposits Extent:  
Infiltration: **None** Pipe Seal Cond: **Sound**

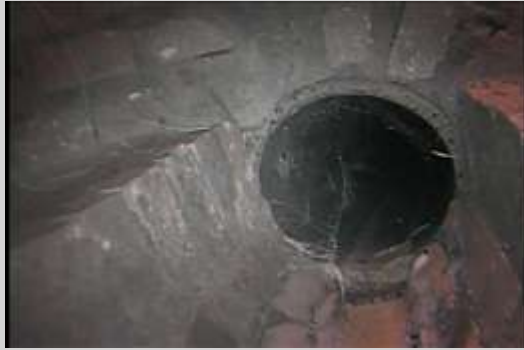
9 O'Clock Inflow

Infiltration: **None** Pipe Seal Cond: **Roots**
